# From darkness to light

the restoration of  
Barton Broad

**Broads Authority**

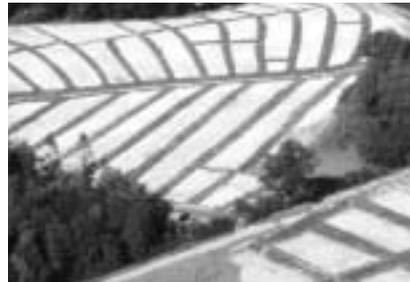
Dredging took six years (1996-2001), removing over 305,000 m<sup>3</sup> of sediment, equivalent to 160 Olympic size swimming pools. This sediment was pumped into specially constructed settlement lagoons on adjacent agricultural land, with topsoil forming bunds to contain the liquid sediment as it dried out. After drying the lagoons had approximately 1m depth of sediment. The restoration of the sediment disposal site back to agricultural land involved mixing dredgings with subsoil, re-covering with topsoil and planting with a conditioning crop of oil seed rape or wheat, before returning to commercial agricultural use.

Left to right:  
suction dredging,  
mud pumped into  
sediment lagoon,  
sediment lagoons

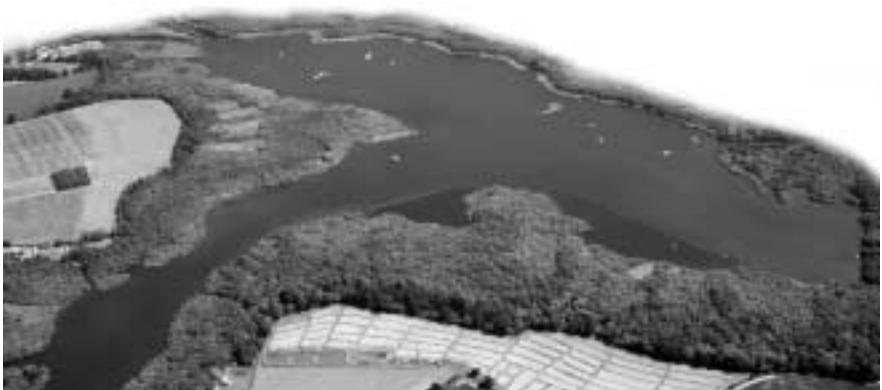
The location of the fields was adjacent to the broad. This meant that any water that ran off the agricultural fields carried nutrients directly back into the broad. Therefore it would have been desirable (but proved impossible here) to site the sediment lagoons and their outflow downstream from the broad.

Aerial view of Barton Broad in relation to the sediment lagoons (bottom right)

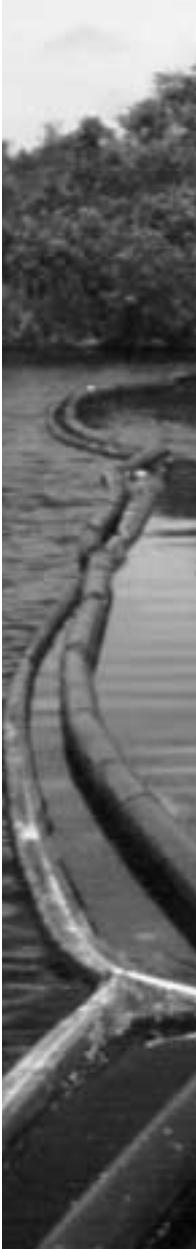
Using a technique called 'electrofishing', fish were captured in nets, whilst they were temporarily stunned. They were then gently transferred into

Left to right:  
installing a fish curtain,  
electro fishing,  
pike (a piscivore)
